Manhole Inspection Summary

Manhole # **S35CC_028MH**

Insp Date: **8/11/08 9:03 AM**

Location Address: **917 CHARLES ST**

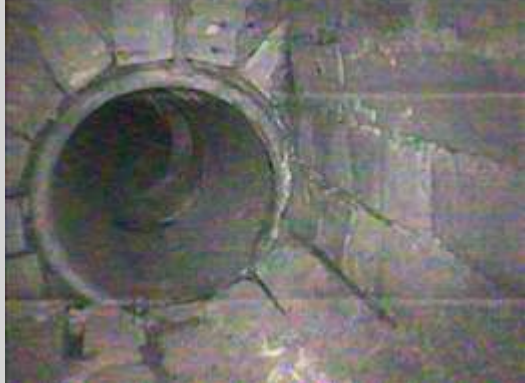
12 O'Clock Outflow

8 in. Circular Gravity Sewer
Pipe Out @ 12 O'Clock

Pipe Material: **Clay** ☐ Pipe Lined

Invert Depth: **8.95** (ft.) Flow Characteristics: **None**

Deposits: ☒ None ☐ Mud ☐ Sludge ☐ Debris ☐ Grease

Infiltration: **None** Pipe Seal Cond: **Sound**
